Dissolved Gas Supersaturation Monitoring At Three Hydroelectric Generating Facilities in the Yukon, Canada, in August of 1997 and 1998

B. L. Antcliffe and A. von Finster

1999

Canadian Technical Report of Fisheries and Aquatic Sciences 2275

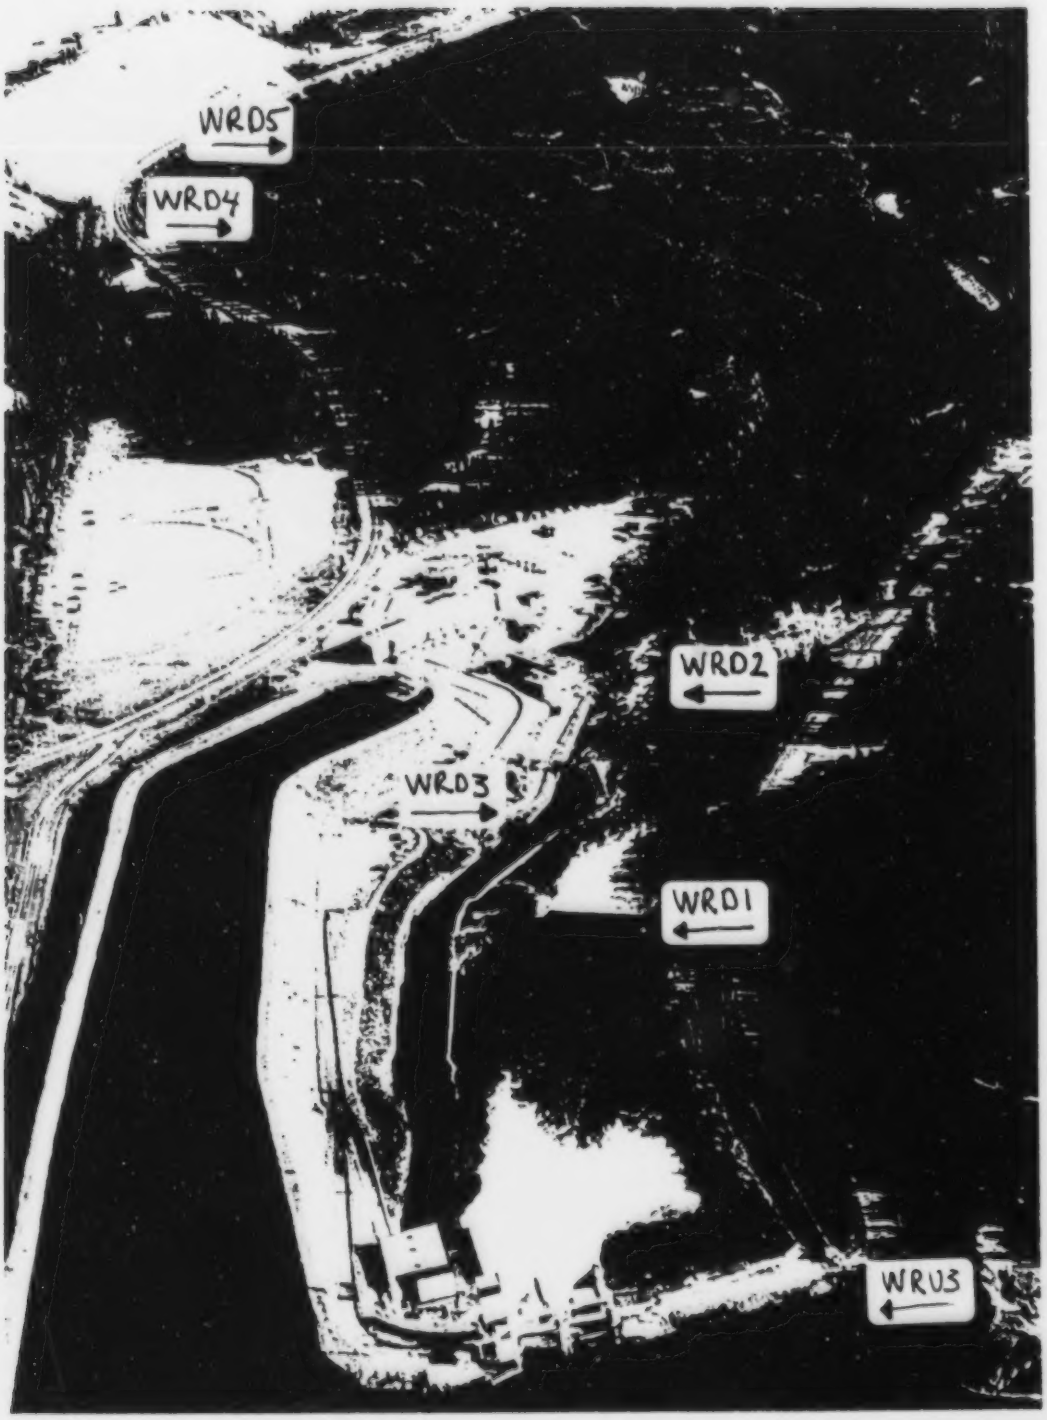
DGS sampling was conducted at the Whitehorse Rapids facility in 1997 and 1998. In 1997, two sampling sites were located upstream of the Whitehorse Rapids facility. The first was offshore of the boat launch located on the south east end of Schwatka Lake and the second immediately downstream of Canyon City. It was necessary to sample a several km upstream of the dam, rather than directly in the forebay, in order to sample water representative of that which flows through the spill gates. Sites immediately downstream of the dam in 1997 were located below the two low-level spill gates but upstream of the barrier weir (sampling location shown in Photo. #3); in the tailrace of unit #4; and downstream of the weir and the confluence of unit #4 (sampling location was in the lower right-hand corner of Photo. #2). Sites located further downstream included one near the infilled section of Robert Service Way, one at the foot of Main Street, near the WP&YR station; one at the upstream end of the MacIntyre Flats, and the final site immediately downstream of the mouth of Croucher Cr.

Figure 1. Whitehorse Rapids Generating Facility, in Whitehorse, Yukon, showing selected DGS sampling sites. Reprinted with permission from Yukon Energy Corporation.

Upstream of the Whitehorse Rapids Dam, TGP ranged from 101.6% (ΔP = 11mmHg) at a depth of 1m, and 102.1% to 102.6% (ΔP = 11 to 19mmHg) at a depth of 3m. Immediately downstream of the two spill gates (just upstream of the barrier weir), DGS was elevated to 113.5% TGP (ΔP = 94mmHg) at a depth of 1.6m depth. There was no elevated DGS from the #4 turbine tailrace, where the measured TGP levels were similar to those found at upstream control sites. Flow from the tailrace diluted downstream TGP levels to 110.7% (ΔP = 75mmHg) at a distance of approximately 500 m downstream from the Dam. Further downstream, TGP was 101.8% (ΔP = 13mmHg) near the Robert Service Campground, and 102.6% (ΔP = 18mmHg) at Robert Service Way. These sites likely monitor flow from the #1,2 and 3 turbine units. Slightly higher TGP levels were recorded further downstream, at the well-mixed sites, where TGP ranged from 105.7% to

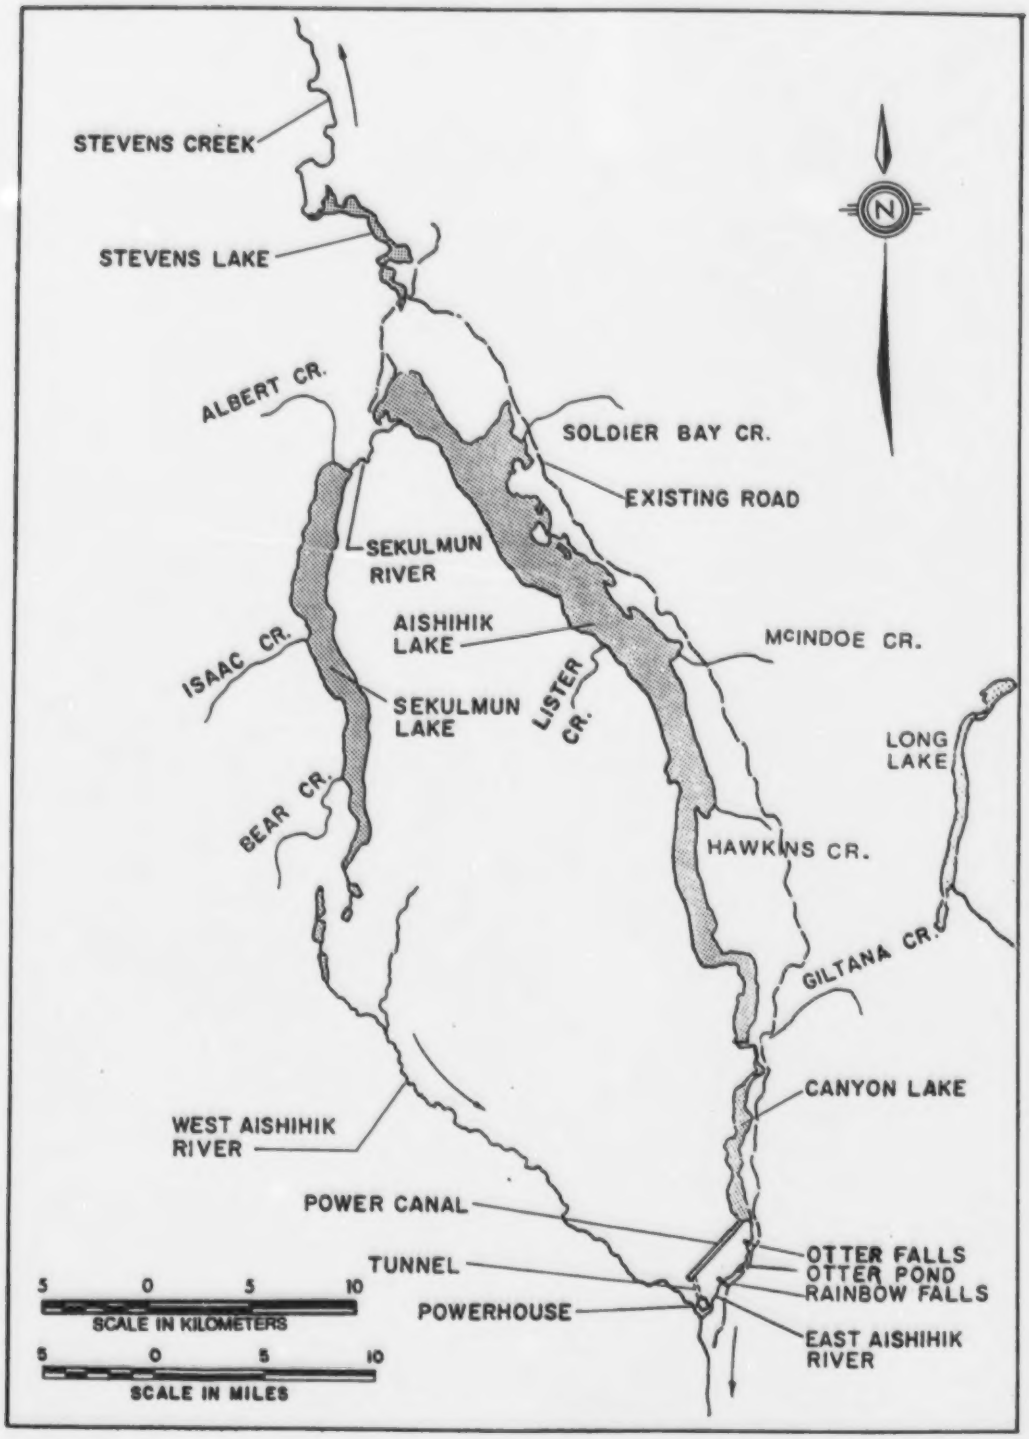
In 1997, upstream sampling sites were located on Aishihik and Canyon Lakes. Downstream sampling sites were located in the tailrace channel, as shown in Photo. # 4 and 5, and the Aishihik River, downstream of the confluence of the tailrace channel with the East and West Aishihik Rivers. In 1998, the tailrace channel was resampled, at approximately the same location as in 1997. A more detailed description of sampling sites is provided in Appendix 4 (1997 sampling) and 5 (1998 sampling).

Figure 2. Aishihik Generating Station. Modified from Brown (1975).

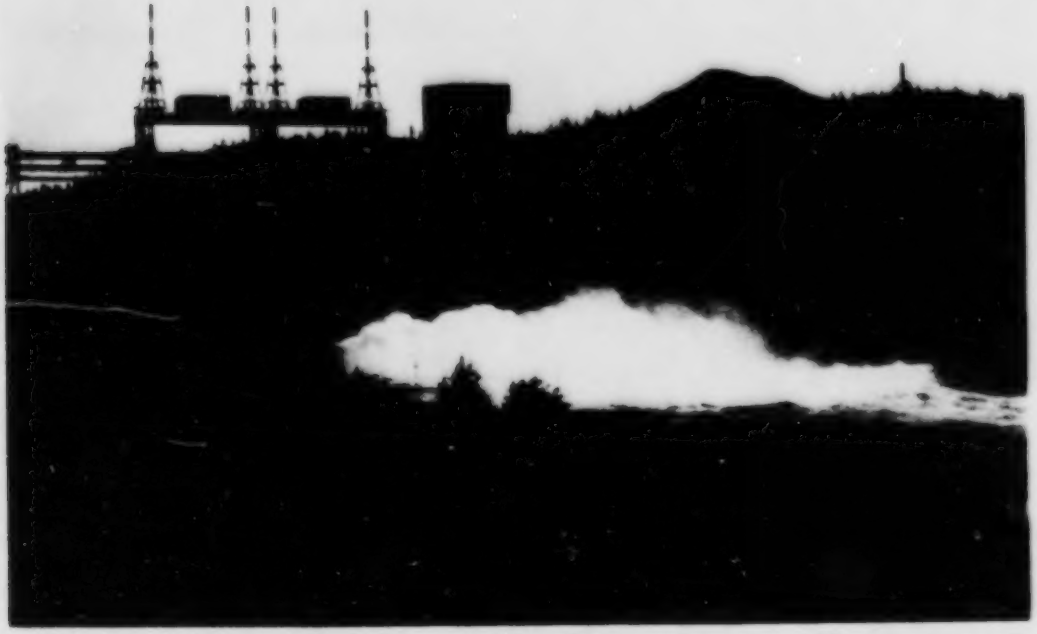
Photo. #1 Whitehorse Rapids Dam showing discharge from two spill way gates.

In 1997 DGS was slightly elevated downstream of the two spill gates (ΔP = 94 mmHg, TGP=113.5%, depth=1.6m), however, flow from turbine #4 diluted the level of dissolved gas tension to ΔP = 75 mmHg (TGP=110.7%, depth =1.5m), at a distance of approximately 500 m downstream from the spill gates. The B.C. water quality guidelines recommend that ΔP not exceed 76 mmHg for water greater than 1m deep (Fidler 1997). ΔP levels in excess of 76mmHg can lead to acute signs of GBT, while ΔP levels between 24 and 76 mmHg can lead to chronic signs (e.g., swimbladder overinflation, bubble formation in the gut). The first acute signs that tend to occur when ΔP levels exceed 76 mmHg are extracorporeal interlamella bubble formation and subdermal emphysema of external skin surfaces, both of which affect juvenile and adult fish. The threshold for bubble growth to occur in the vascular system, which can lead to death, begins at a slightly higher ΔP of approximately 115 mmHg. And the higher the ΔP levels, the shorter the time to mortality. Downstream of the Whitehorse Rapids Dam TGP was below the threshold for bubble growth to occur in the vascular system. However, some TGP measurements were in the range where mortality has been observed in the literature (ΔP between 76 and 115 mmHg). The cause of mortality when TGP is greater than 76mmHg but below 115mmHg is unknown, may be related to chronic effects which ultimately lead to death.

The relatively low levels of DGS measured downstream of the spill gates are not surprising, given that the spill gates act as low-level ports, and the discharge appears to have a horizontal velocity component. This would tend to prevent much or most of the water from plunging to depth, where hydrostatic pressure would force gas from inside air bubbles into solution. Although some turbines may produce DGS as a result of air entrainment, at Whitehorse Rapids, turbines #1 to 3 and #4 do not produce any significant DGS.

TGP should be measured during conditions of high spill volumes and warm water temperatures to determine whether the recommended guideline of 110% is met under various conditions, and to assess potential chronic effects.
